NOVEMBER 13, 2023

RE: POST-FIRE EVALUATION: SUPPLEMENTAL LETTER: COLLINS RESIDENCE, VFES OK-04.28.2021.01: 1312 WEST 60TH STREET NORTH, MUSKOGEE, OKLAHOMA:

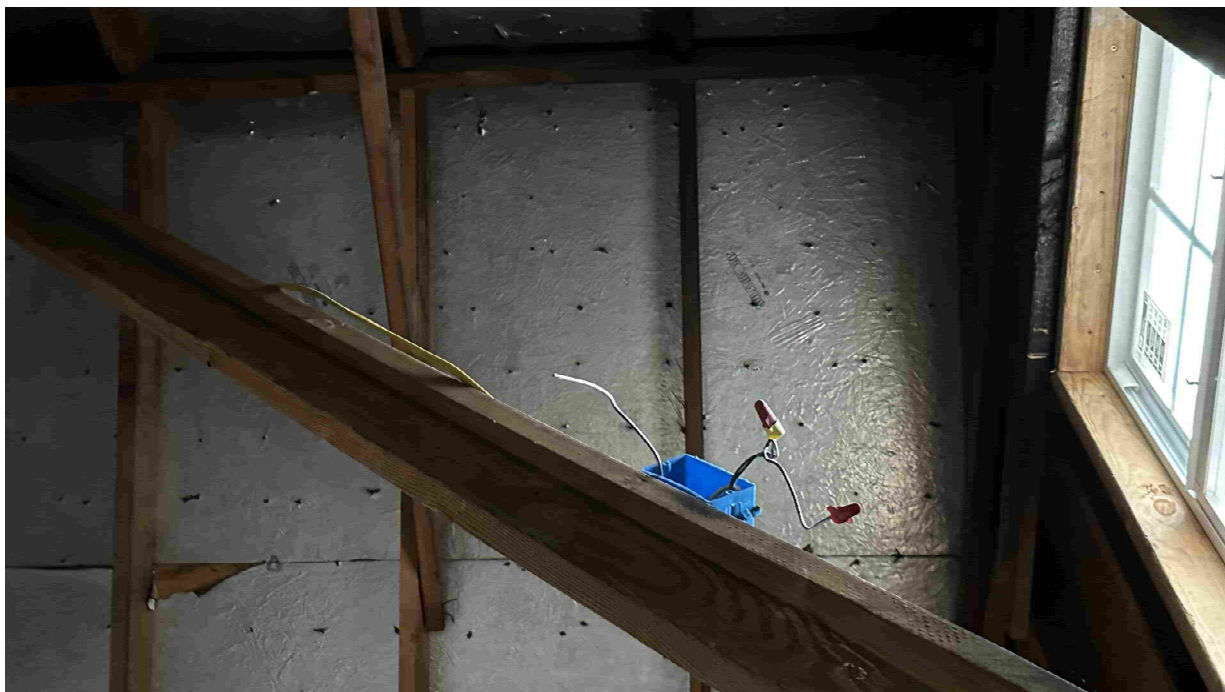
Attic 2 is identified on Page 11 of 60 of the source PDF of the VanDorn Report and represents the attic over the eastern second-story section of the dwelling. The location chosen for discussion by VanDorn is located along the west side of the east attic and was indicated by VanDorn to be 'more than 30' from the nearest fire damage'. This statement is misleading and inaccurate. Image 4.1 shows an area of damaged radiant barrier to the roof decking less than 6 feet from the west wall of the east attic. In this image, the charring of the framing for the window is apparent. Furthermore, as shown in Figures 4.1 and 4.2, sections of the adjoining radiant barrier are deformed in an area that would be directly above where the fire has damaged and consumed portions of the wall framing. The commentary from VanDorn, as quoted above, is inaccurate and misleading. As such, the VanDorn commentary, as quoted above, should be withdrawn.

4.1: VIEW OF THE DEFORMED RADIANT BARRIER ALONG THE WEST SIDE OF THE EAST ATTIC.

Further consideration should also be given to the consequences of the radiant barrier roof decking from the removal and replacement of the laminate-style asphalt-composition shingle roof assemblies. The necessary use of nails to secure the new shingles will result in additional holes and displaced sections of the radiant barrier. This additional alteration of the wood decking would not return the residence to a pre-fire condition.

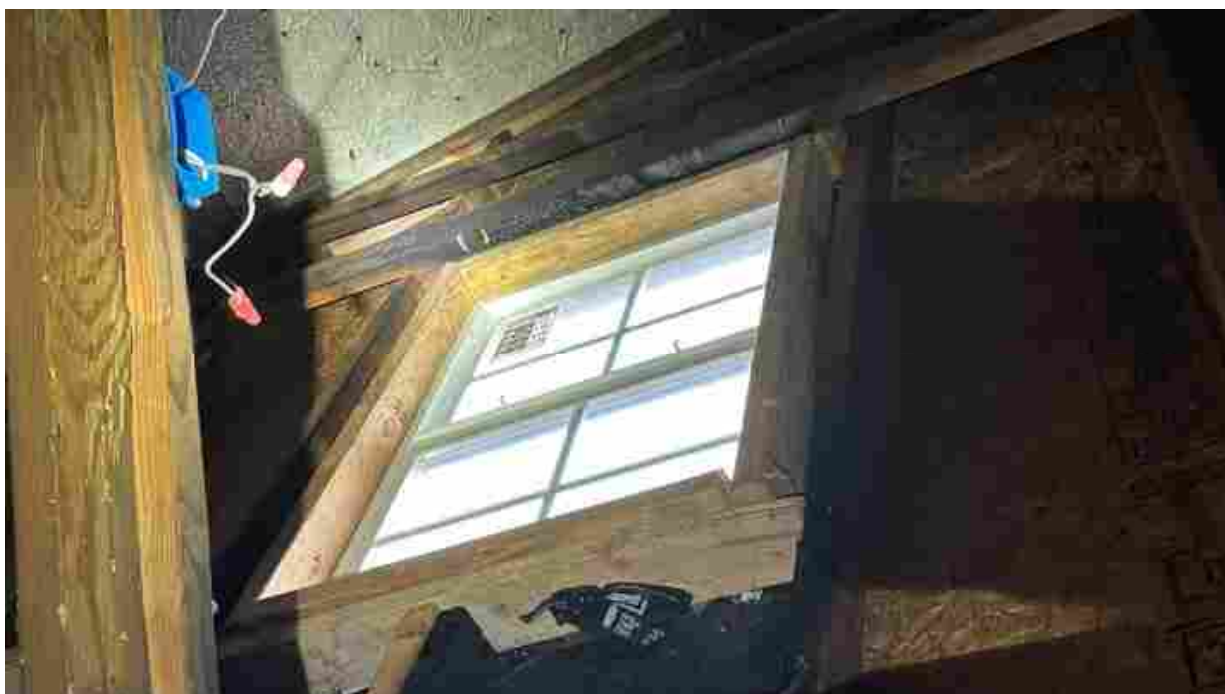
4.2: VIEW OF FIRE-DAMAGED FRAMING ALONG THE WEST SIDE OF THE EAST ATTIC AND DIRECTLY BELOW AN AREA OF DEFORMED RADIANT BARRIER TO THE ROOF SHEATHING.

The wall framing on the south-facing gable for the west-facing two-car garage and along the west side of the east attic indicated burned wall framing and sheathing. When gable infill walls are constructed, the initial wall framing studs are erected and attached to framing above and below. Sheathing, in this case, oriented strand board (OSB), is installed from the outside. The nails that secure the sheathing are nailed from the outside, extending through the sheathing and into the studs. Moisture barriers are then installed to the outside and secured into the sheathing. When a brick or stone veneer is present, the metal ties that secure the masonry veneer are nailed through the sheathing and into the wall framing. If windows are present, the flanges of the windows are nailed through the sheathing and into the wall studs. Additional flashing is completed between the window and wall assembly. This is common construction practice and something that would be anticipated for VanDorn to understand based on his statement in his qualifications.

To reconstruct even portions of the wall, it is necessary to deconstruct from the outside, first removing the siding or veneer, then the moisture barrier, and then the damaged sections of sheathing before replacing the framing sections. This is a significant demolition that will disrupt the wall. To restore the residence to a pre-fire condition, it is recommended to reconstruct the wall. The removal of individual framing members or spraying of a coating will not restore the property to a pre-fire condition. The loss of cross-section from the reuse of charred framing or wall sheathing will reduce the overall strength of the wall compared to a pre-fire condition. VanDorn mentions that *'It is a common practice to repair fire damage within a framed section without replacing the entire section'*. Simply because something may have been done in the past

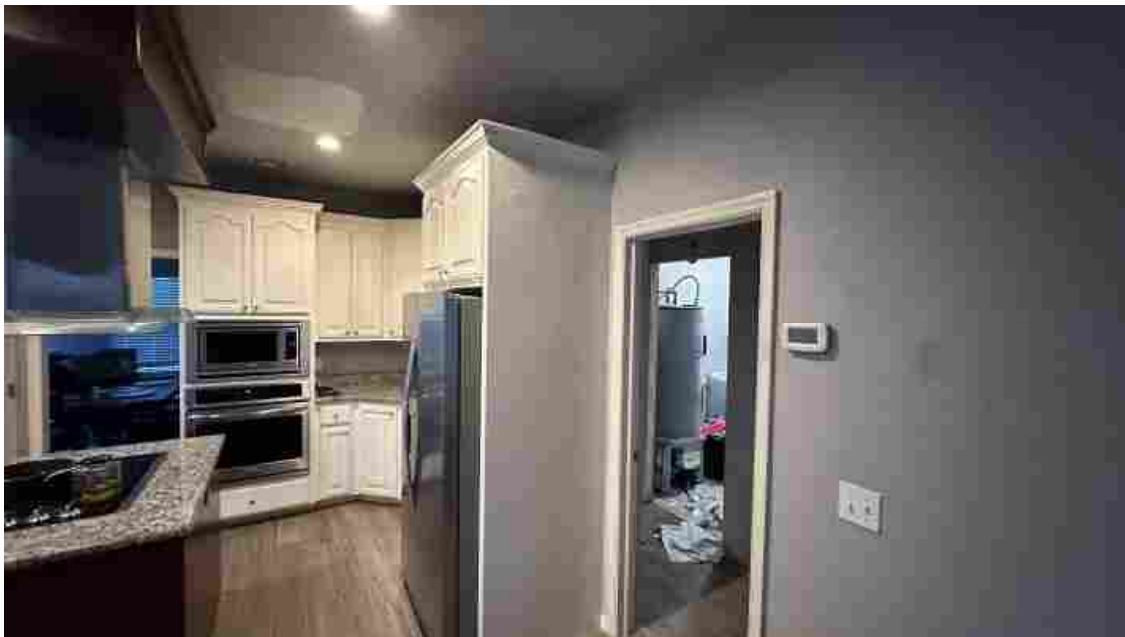
The intent of the passage was to indicate that any fire-damaged cabinets be removed and replaced. If it were not possible to restore the cabinetry through matching individual replacements, then removal and replacement of the cabinets as a unit would be necessary to maintain the cohesive appearance of the kitchen cabinets. It should also be noted that efforts to disassemble cabinetry and trim typically result in damage to remaining sections through remnant nail holes and other conditions from disassembling a system that was not designed to be taken apart. Figure 4.3 shows the attempted restoration of the refrigerator cabinet. Figures 4.4 and 4.5 are closer images of the repair and the degraded appearance of the cabinetry/trim.

4.3: OVERVIEW OF THE KITCHEN ON 10.27.2023.

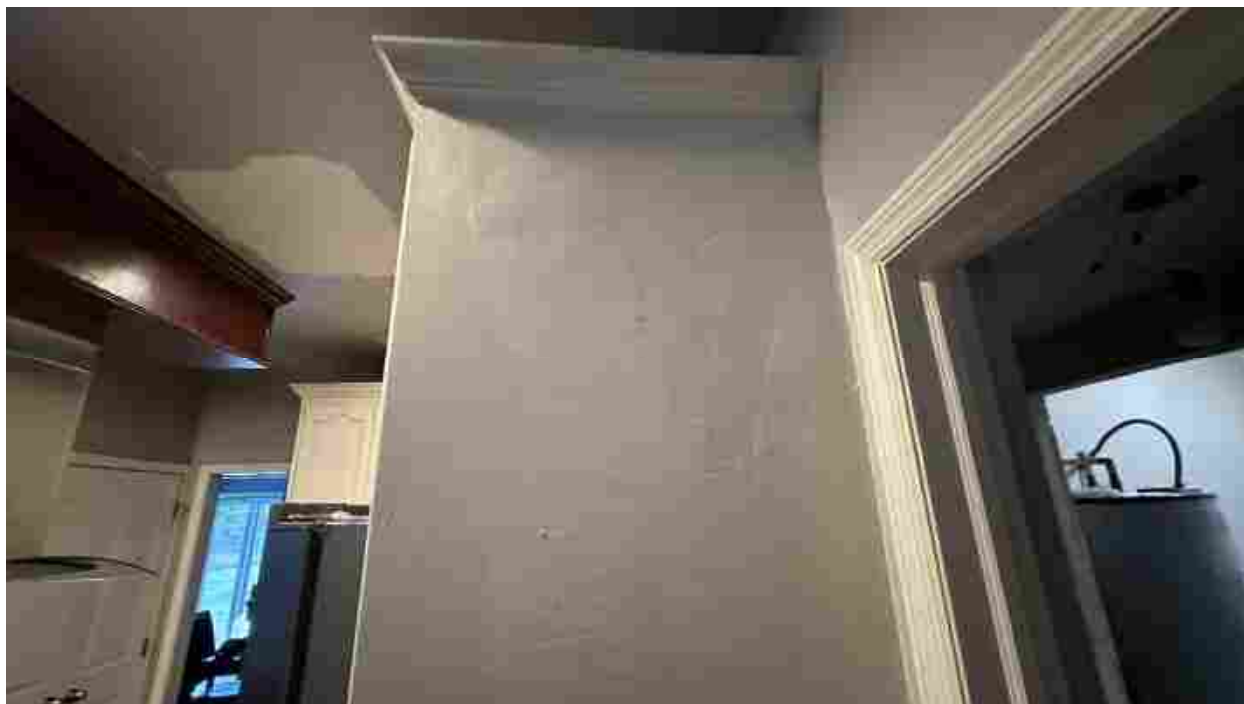
4.4: VIEW OF THE UNEVEN SURFACE ALONG THE NORTH WALL OF THE KITCHEN CABINET: 10.27.2023.

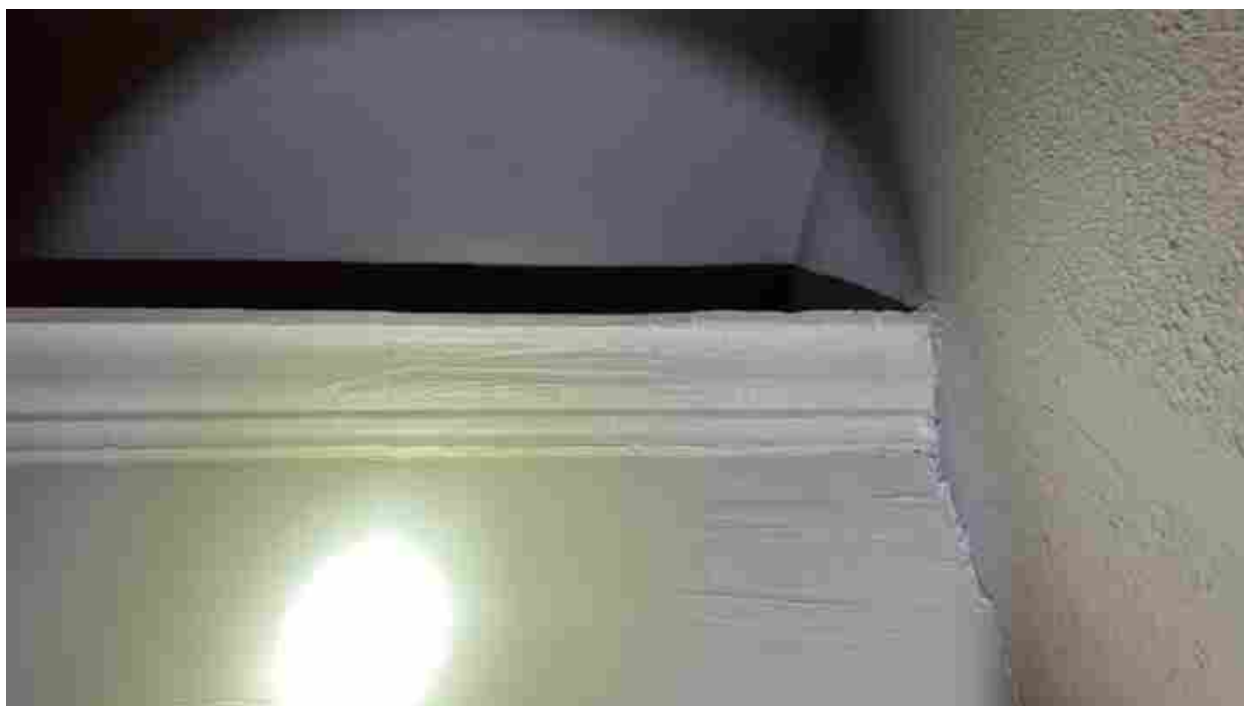
4.5: VIEW OF THE POOR TRIM FINISH ABOVE THE REFRIGERATOR CABINET: 10.27.2023.

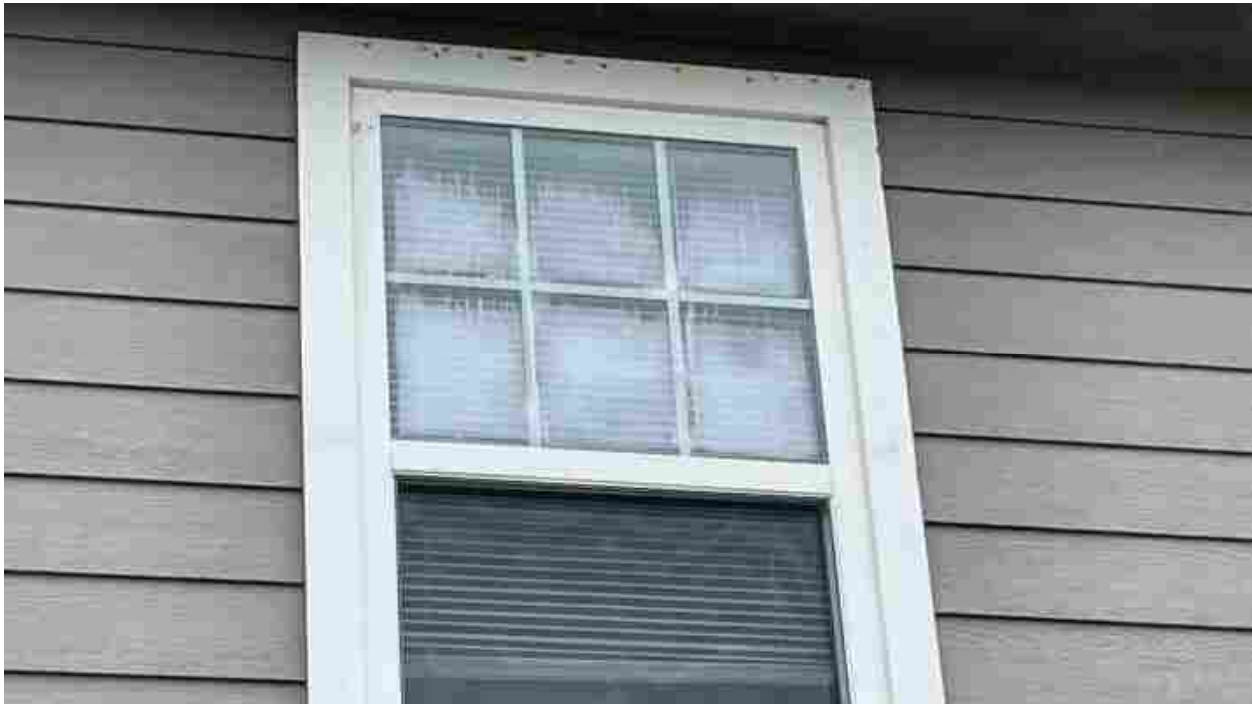
VanDorn asserts that there was 'no fire damage' as part of his justification for excluding fire as a cause for the failure of the east wind of the second-floor southwest bedroom. Figure 4.6 shows the condition of the window (from the exterior) on May 4, 2021. Figures 4.7, 4.8, and 4.9 show the accumulation of soot along the west and south walls of the southwest bedroom. It should also be noted that the fire was burning in the second-floor space just west of the southwest bedroom.

4.6: EXTERIOR VIEW OF THE EAST WINDOW OF THE SECOND-FLOOR SOUTHWEST BEDROOM.

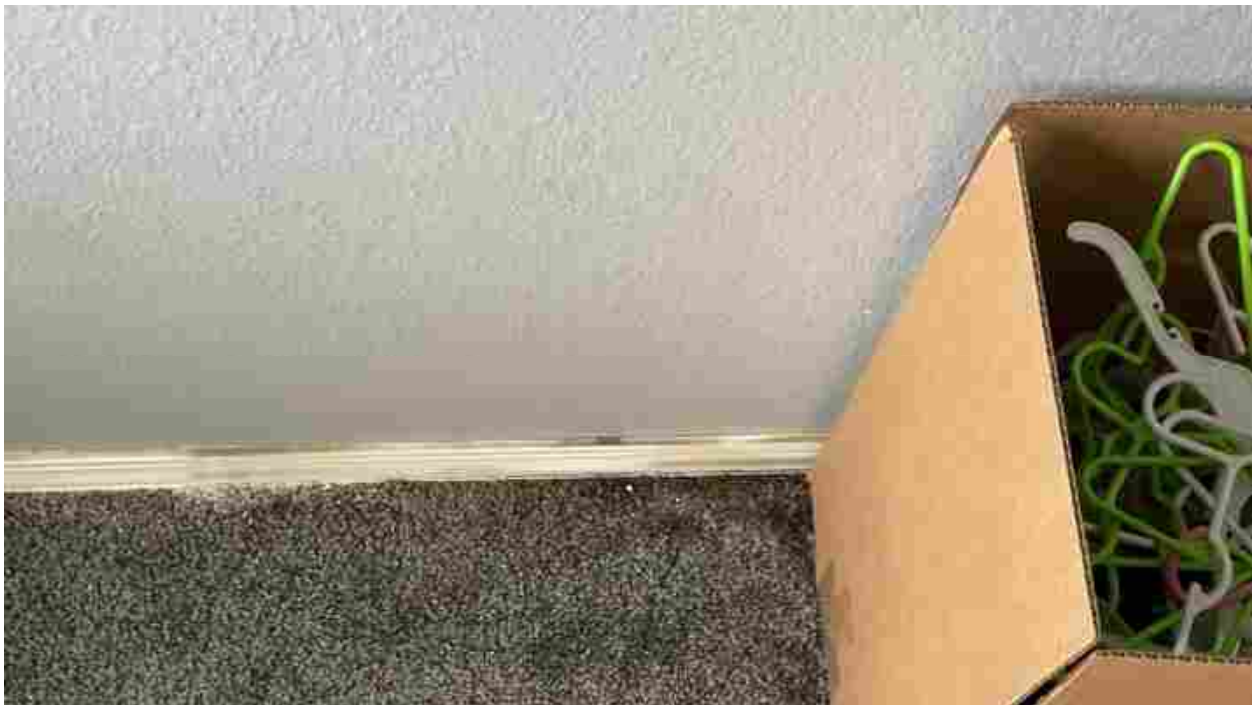
4.7: SOOT DEPOSITS ALONG THE TRIM FOR THE WEST WALL OF THE SECOND-FLOOR SOUTHWEST BEDROOM.

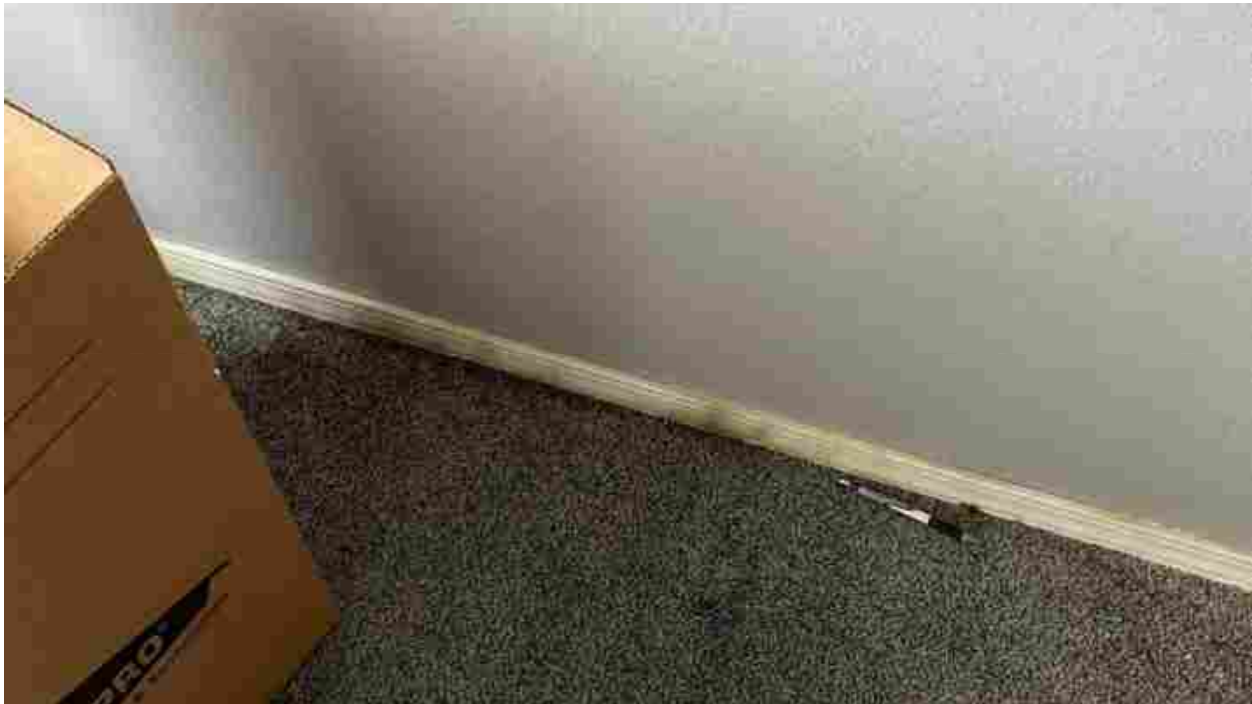
4.8: SOOT DEPOSITS ALONG THE TRIM FOR THE WEST WALL OF THE SECOND-FLOOR SOUTHWEST BEDROOM.

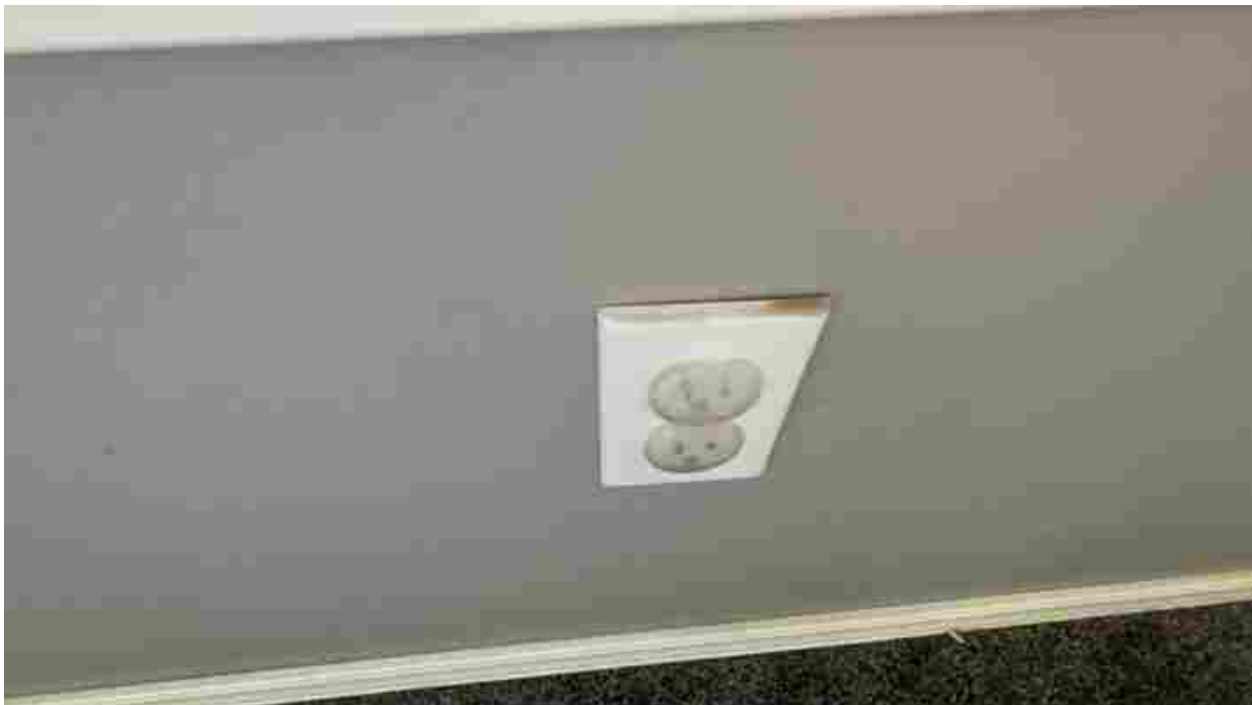
4.9: SOOT DEPOSITS ALONG THE ELECTRICAL OUTLET FOR THE SOUTH WALL OF THE SECOND-FLOOR SOUTHWEST BEDROOM.

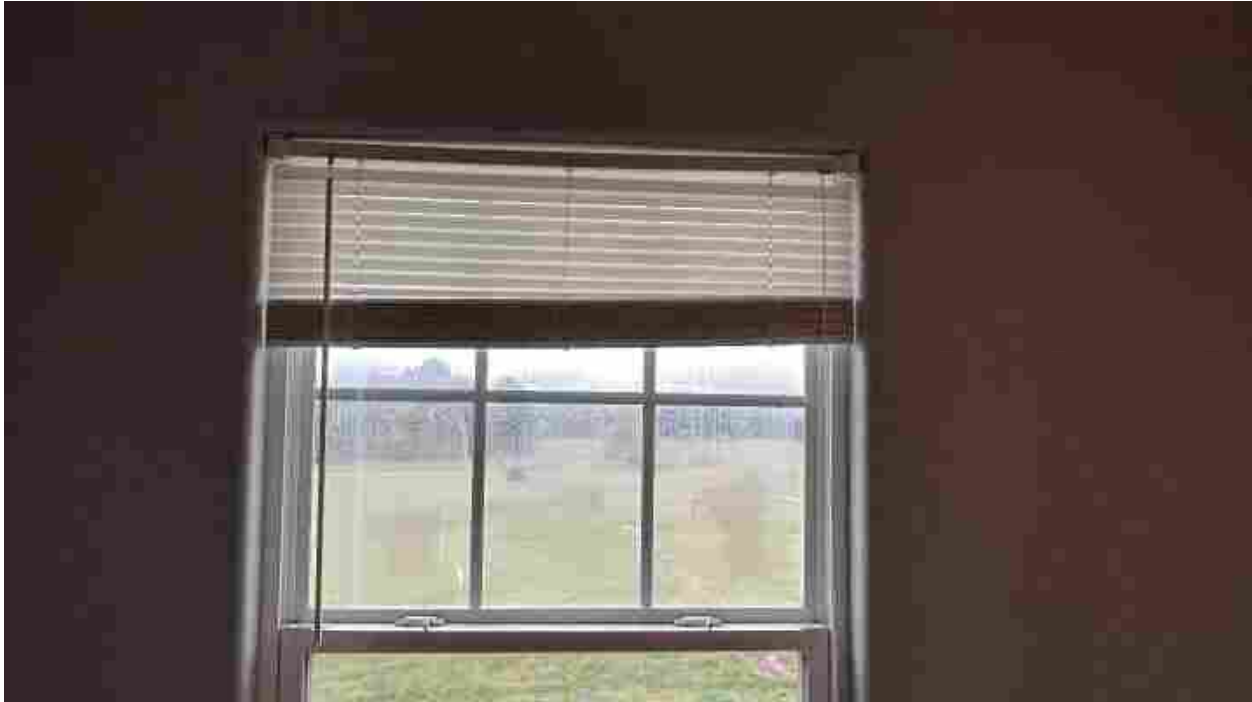
4.10: A VIEW OF DARKER DISCOLORATION WITHIN THE EAST WINDOW OF THE SECOND-FLOOR SOUTHWEST BEDROOM.

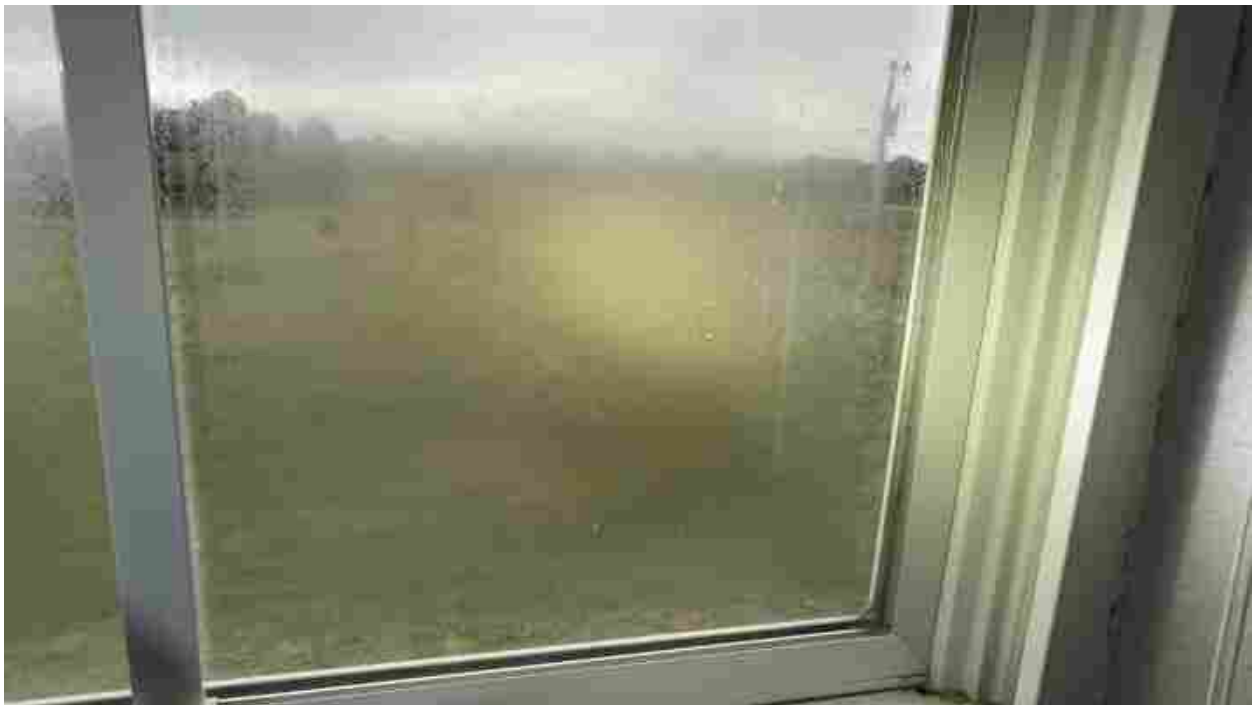
4.11: A VIEW OF DARKER DISCOLORATION WITHIN THE EAST WINDOW OF THE SECOND-FLOOR SOUTHWEST BEDROOM.

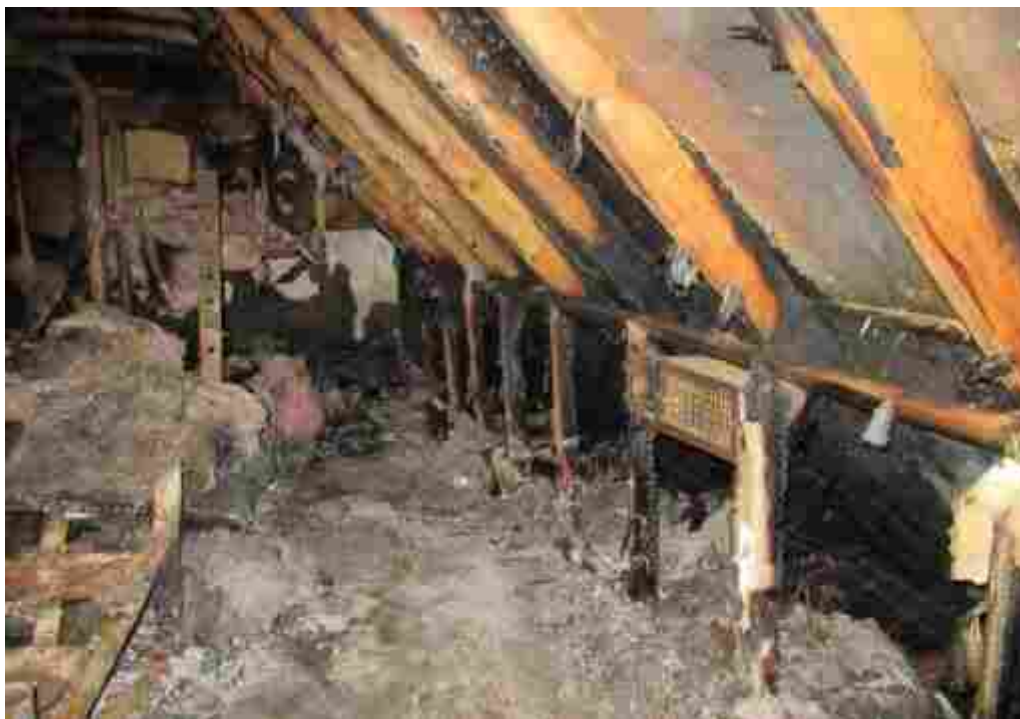
The west wall and sloped ceiling of the exercise room with the attic space just beyond the vertical stud wall framing members. This is near the reported fire origin.

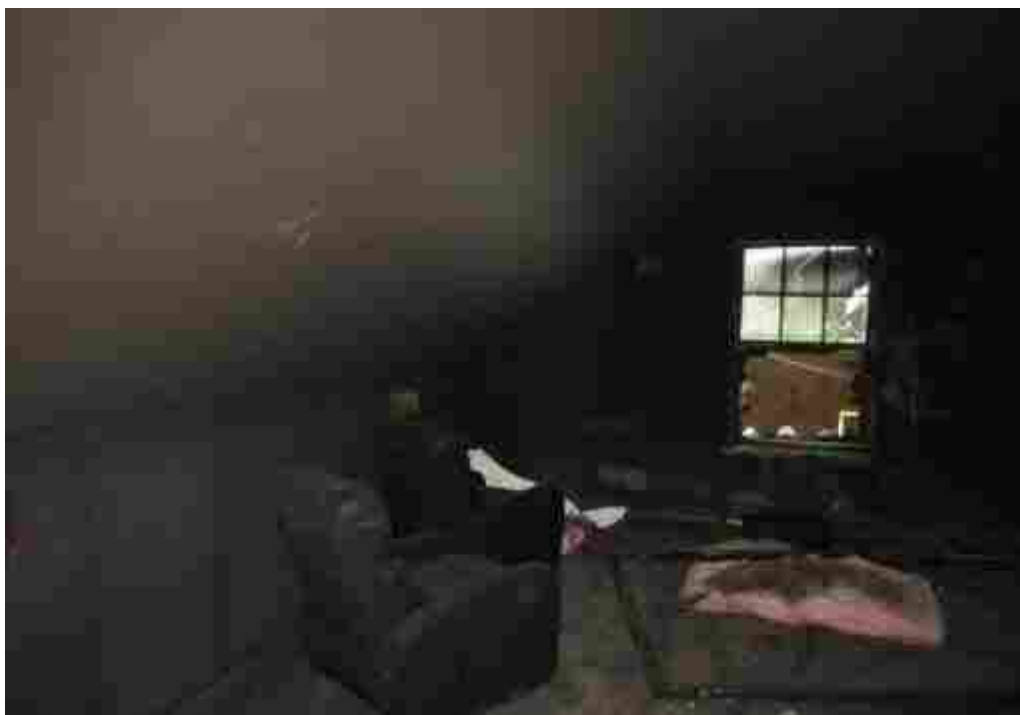
The south wall of the movie room with the fire being contained behind the sheetrock and within the attic cavity.

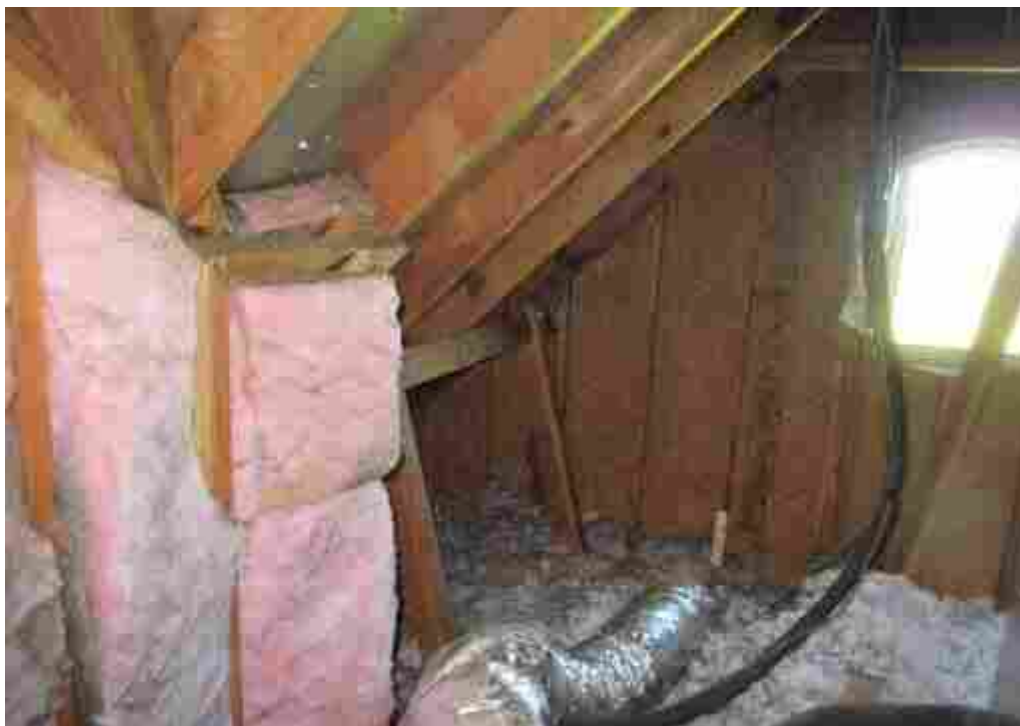
The walk-in attic to the east of the theater room. This area suffered no fire damage.
Minimal smoke residue was evident.

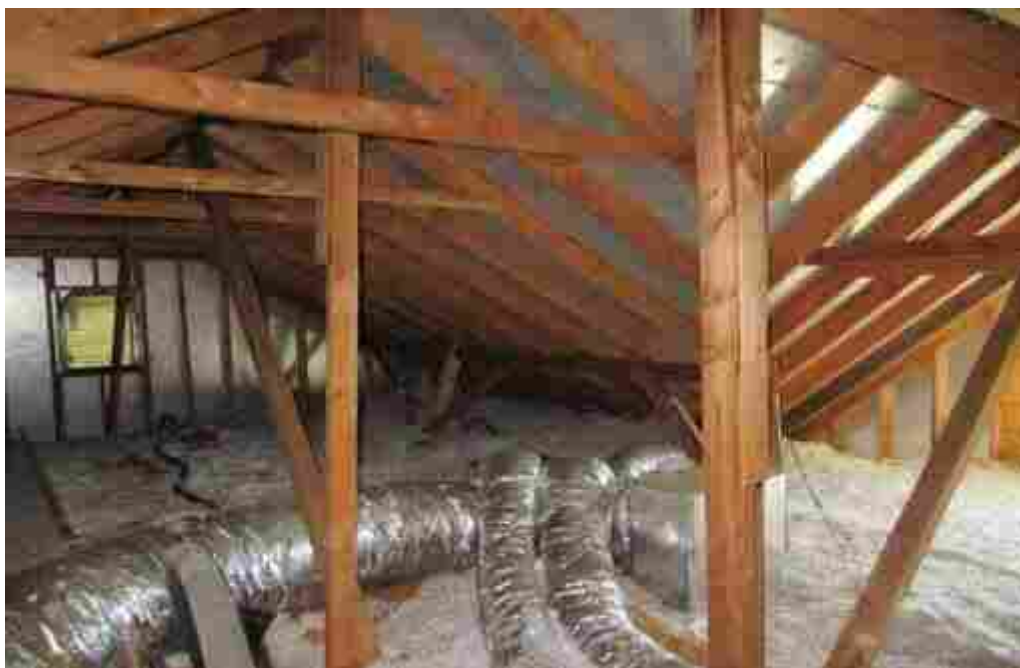
Attic 2. Except for a small area at the gable wall, the fire did not reach this space.

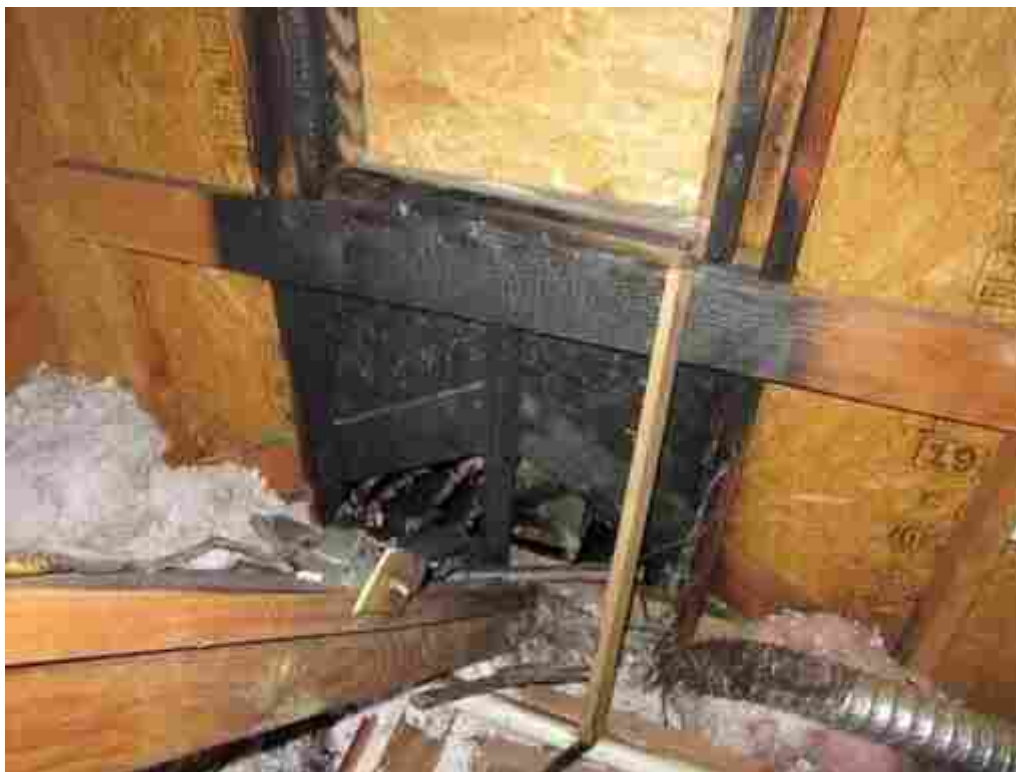
The exercise room is located just beyond and partially below the window at the upper part of this photo. The fire burned through the triangular opening at the bottom and up to and around the window. This was the limit to the fire damage in Attic 2.

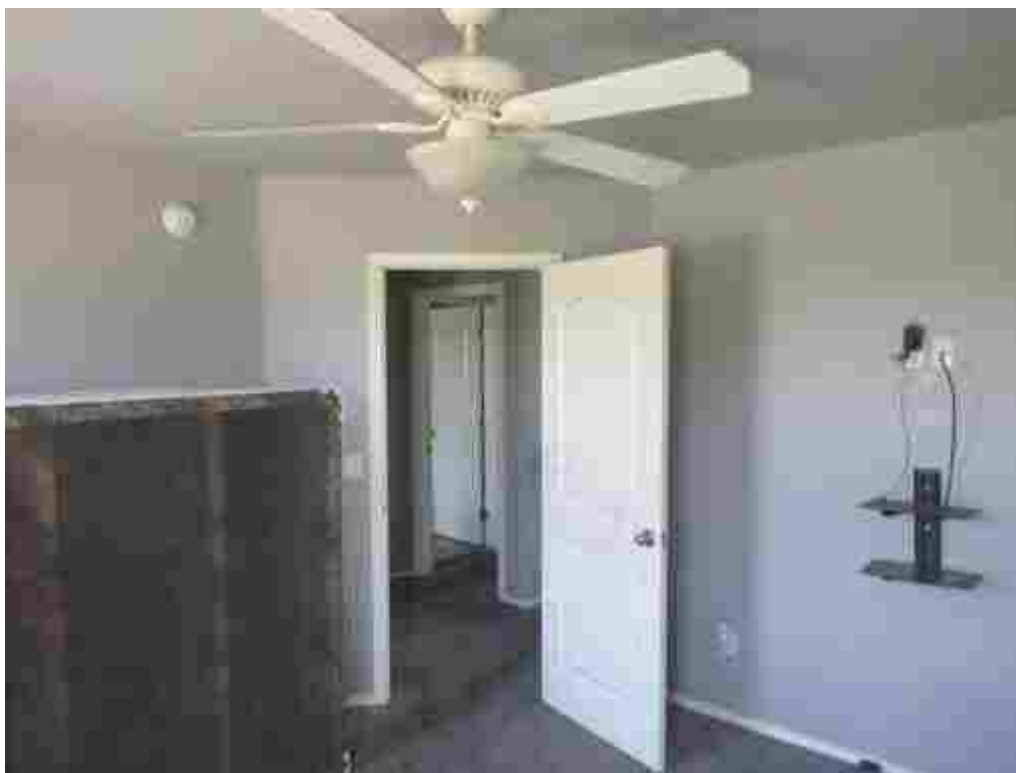
Upstairs Bedroom 1 had minimal soot settlement on the walls, doors, trim, lights, etc.

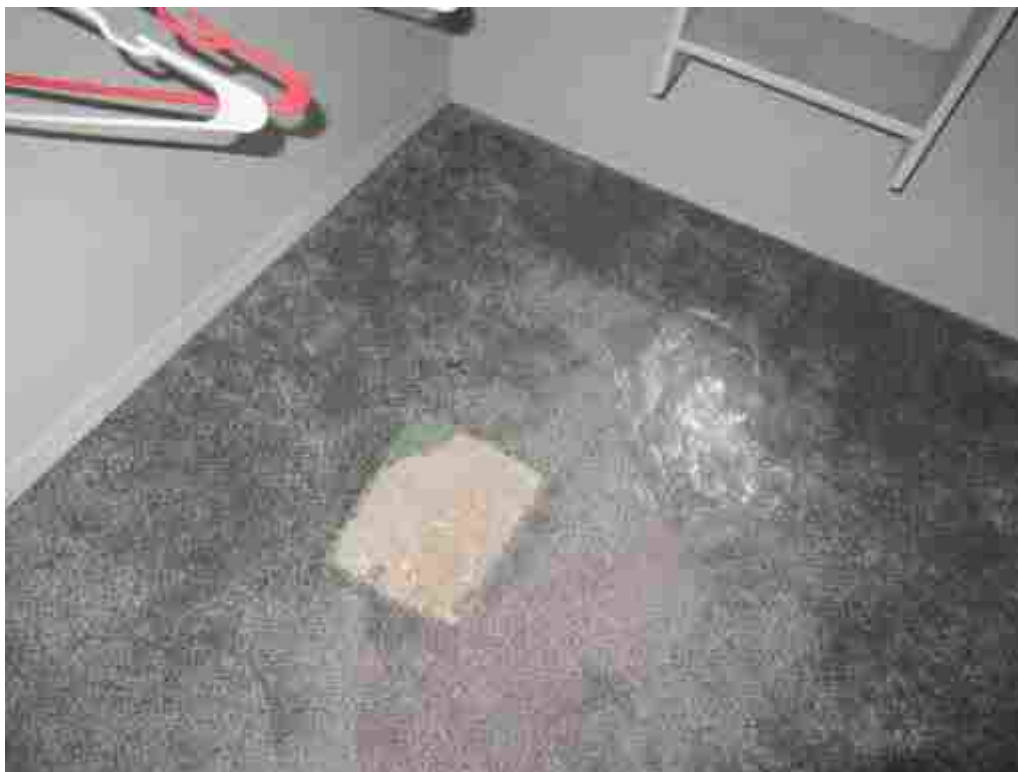
Bedroom 1 Closet with minimal soot present. A piece of the carpet and pad was removed to send to a third-party to determine the reasonable cost to replace the items.

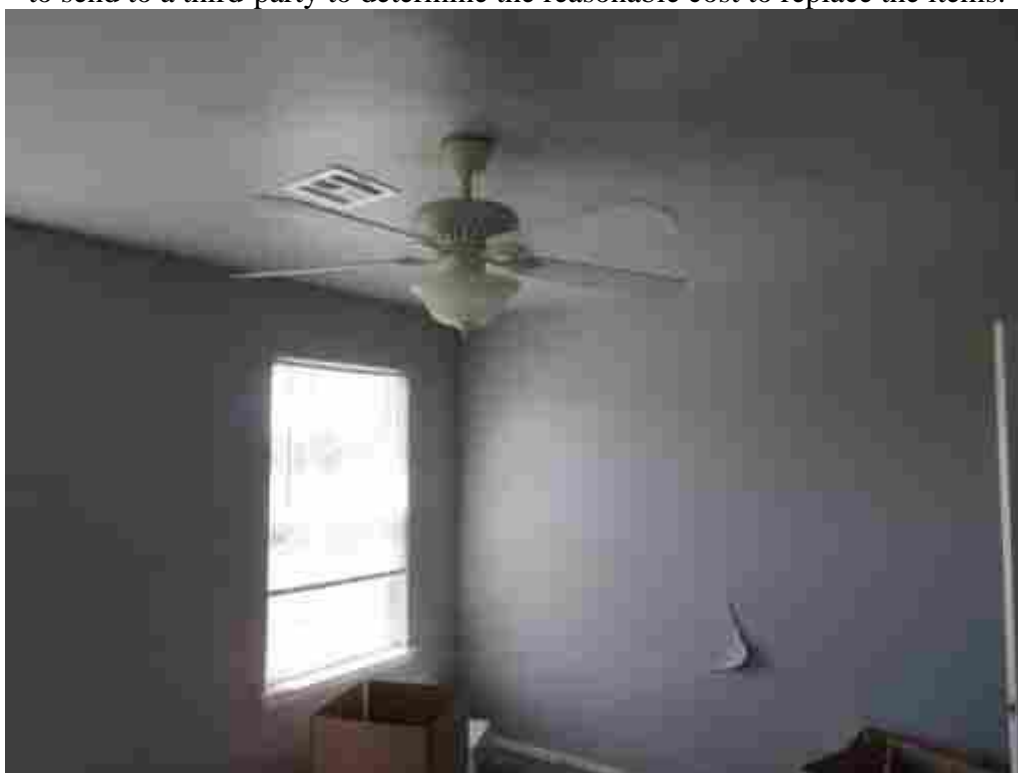
The west wall of Bedroom 2. The hole in the wall appears to have been caused by the fire department when engaging the fire in Bonus Room 1 nearly on the other side of the wall.

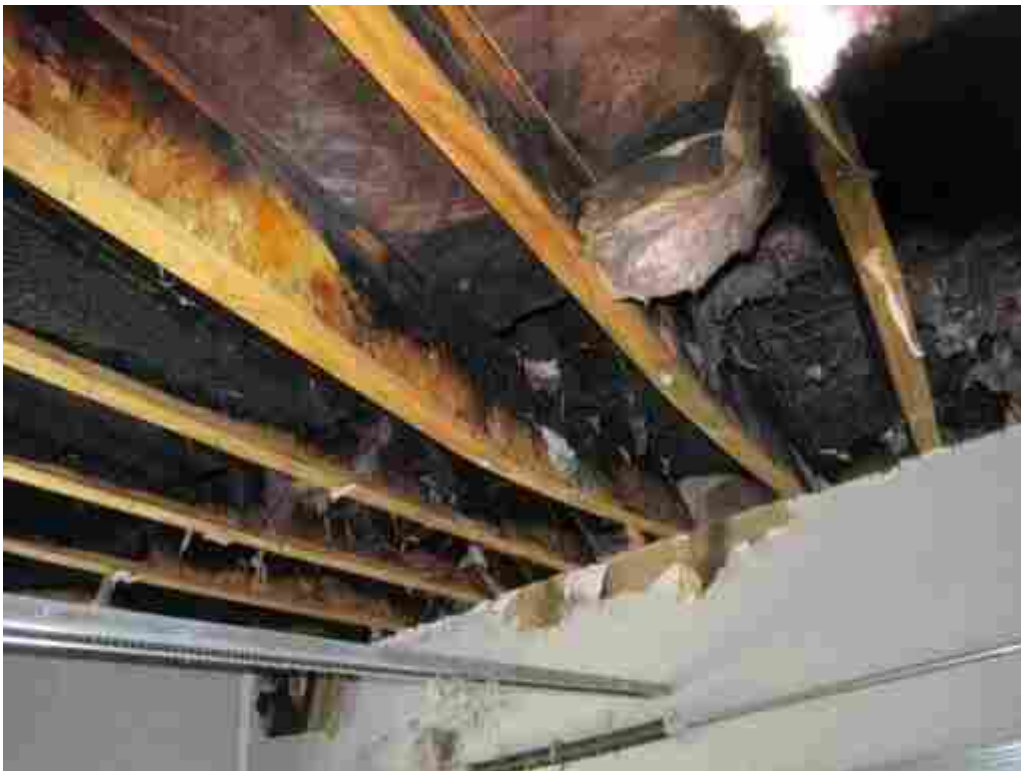
The joists which are sagging in the vicinity of the understood location of the fire's origin.

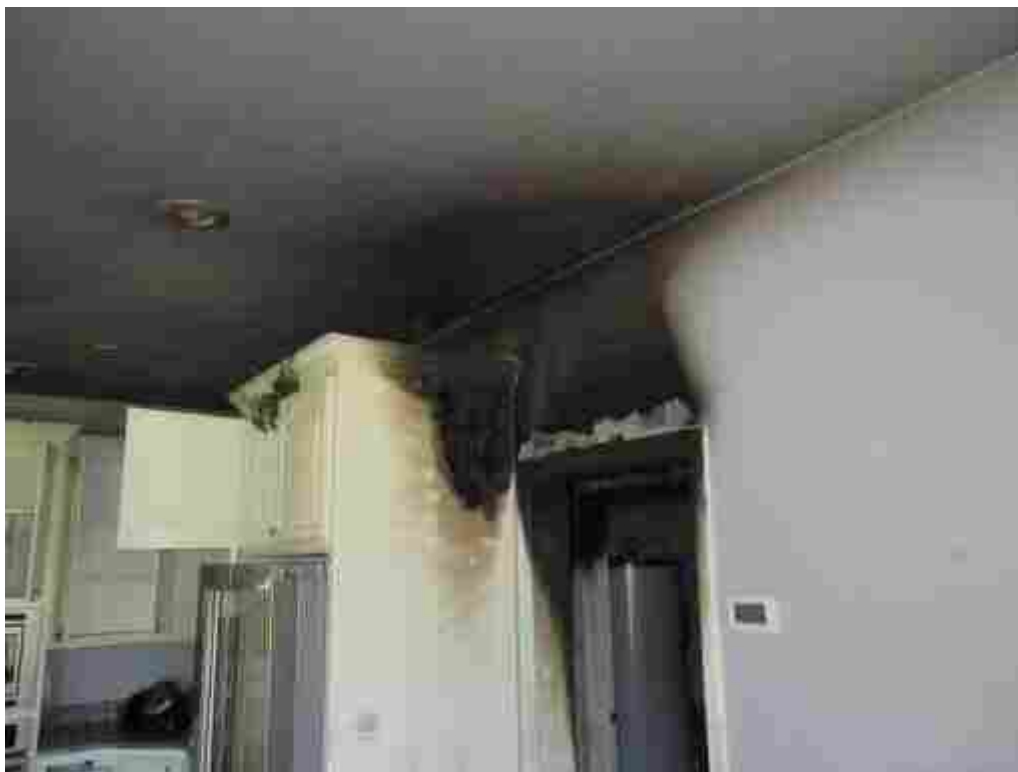
Fire damage to the wall and the top of the refrigerator bulkhead.

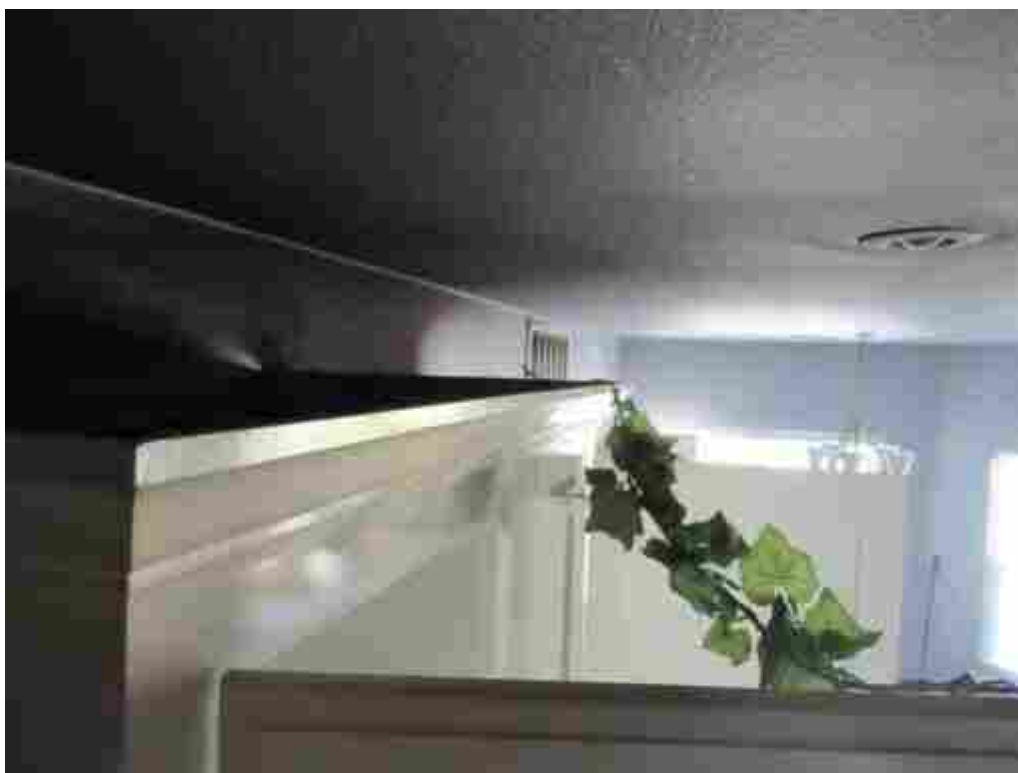
The top of the cabinet above the refrigerator with no damage. The other cabinets within the kitchen were in this same undamaged (by fire) condition.

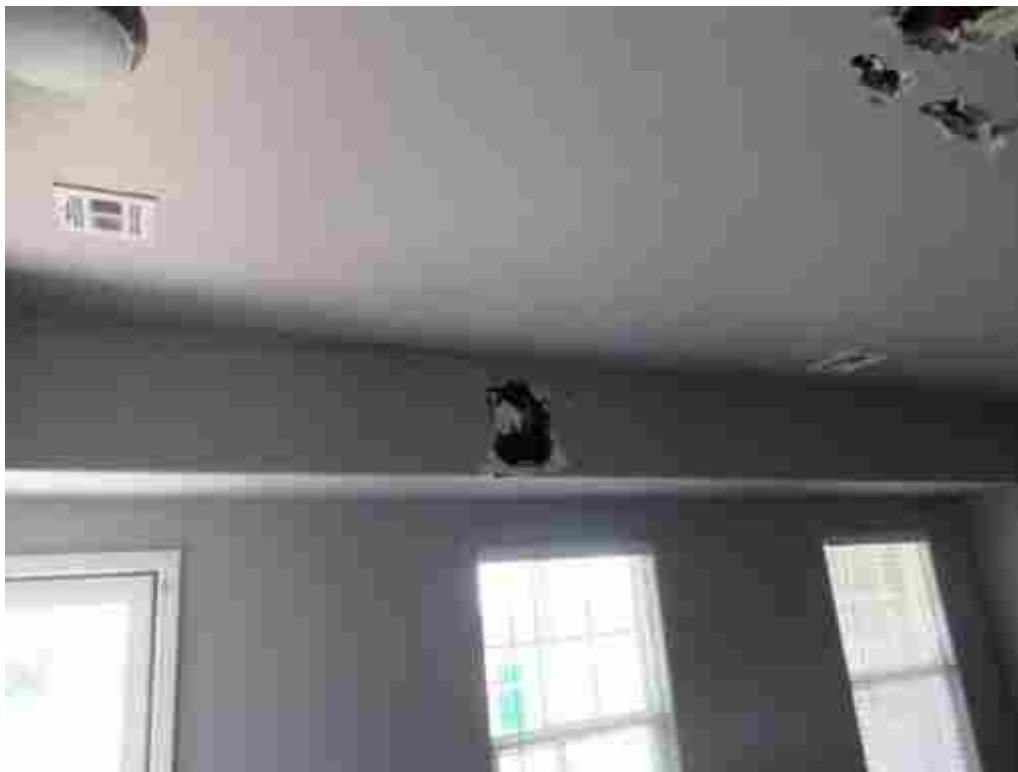
Holes in the ceiling and wall of the Dining Room.

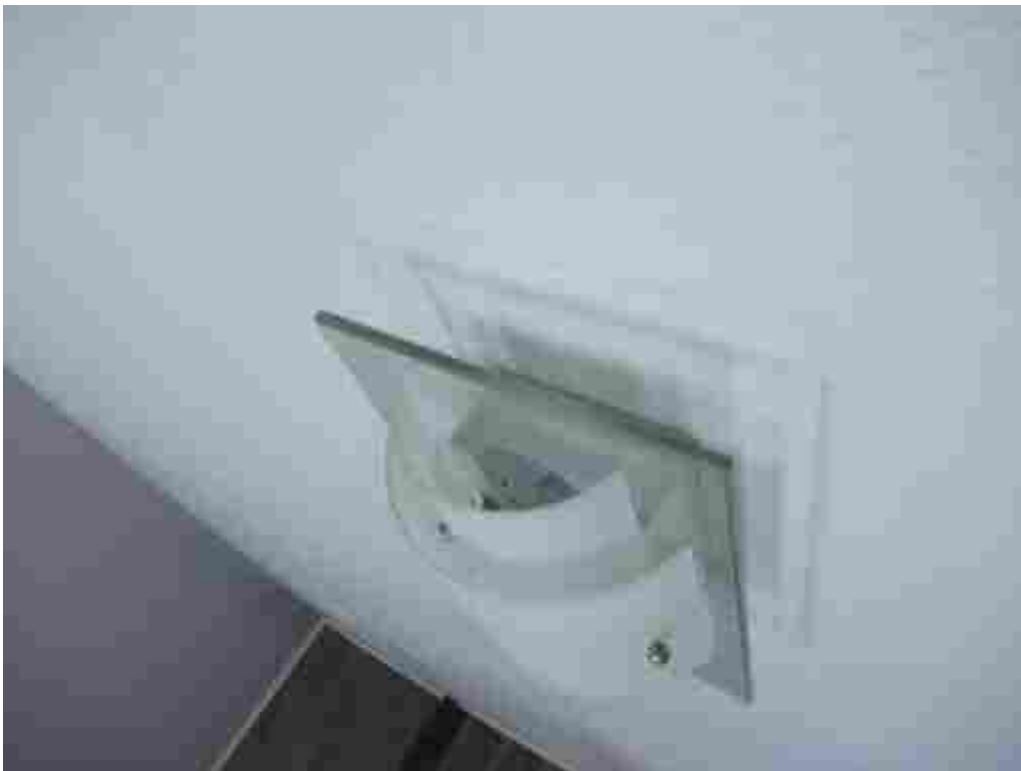
A sconce light installed at the stairwell to the second-floor bedrooms. Cleaning of this light fixture will address the minimal soot accumulation.

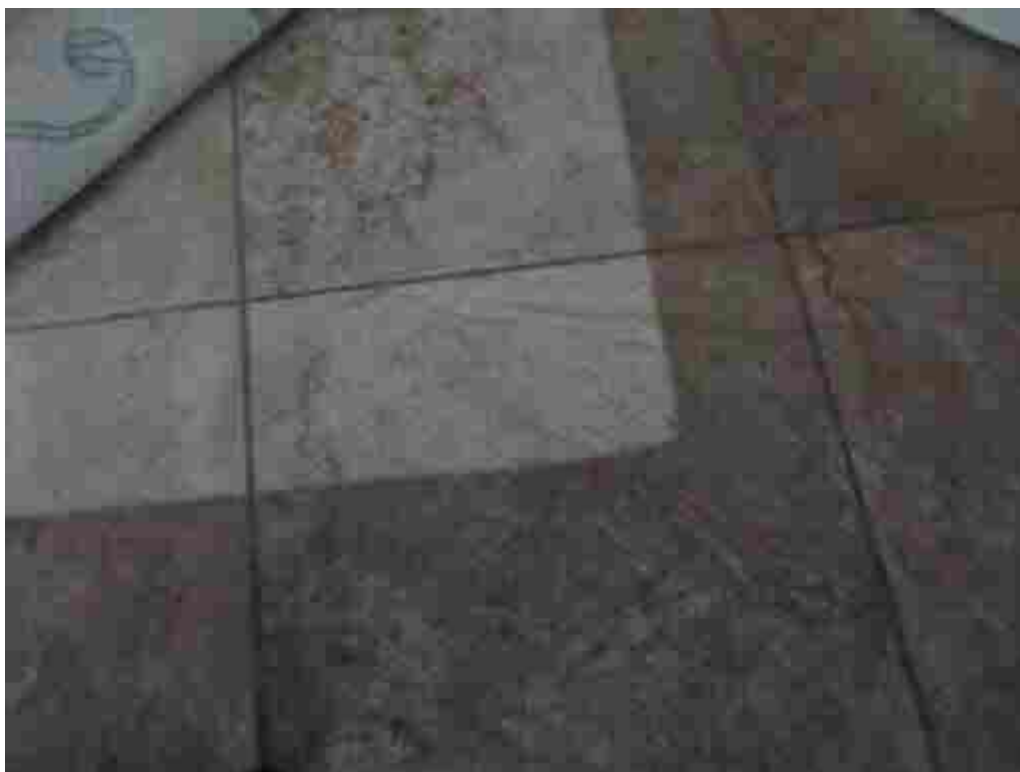
Location of the Guest Bath test clean before cleaning. A floor mat had protected the tile from smoke and soot.

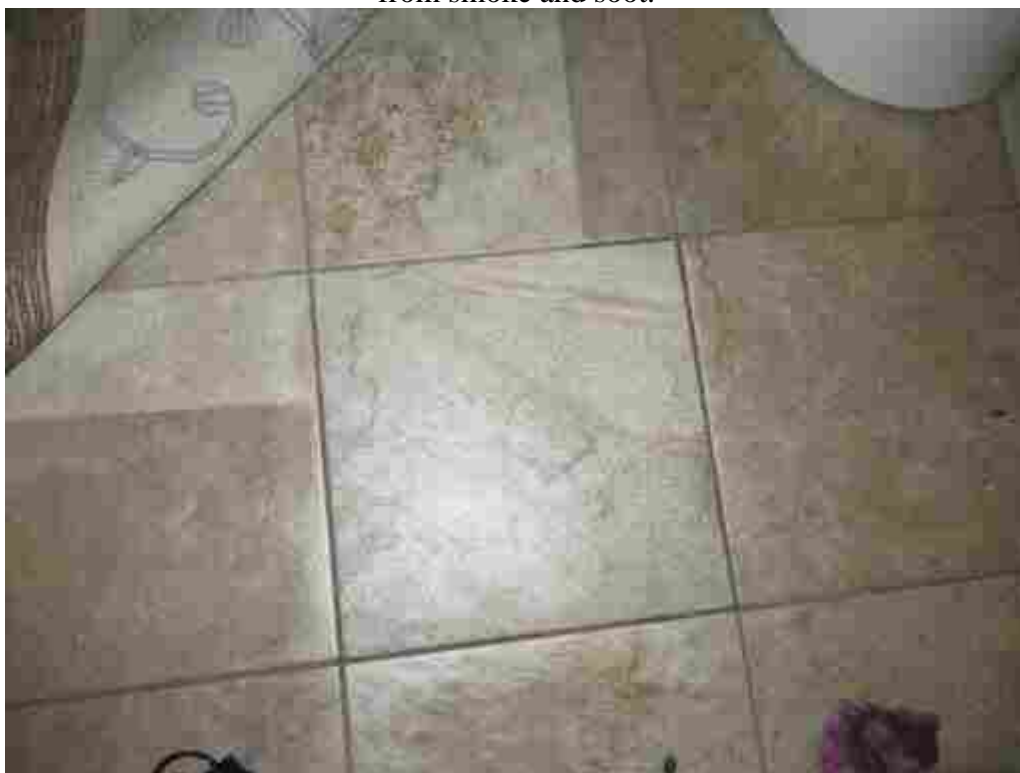
The same area after the test clean. The soot has been fully removed from the tested area.
